INFANT MORTALITY TESTING OF HIGH ENERGY-DENSITY CAPACITORS USED ON NOVA*

B. T. Merritt, K. Whitham
Lawrence Livermore National Laboratory
P.O. Box 5508, L-494
Livermore, CA 94550

Summary

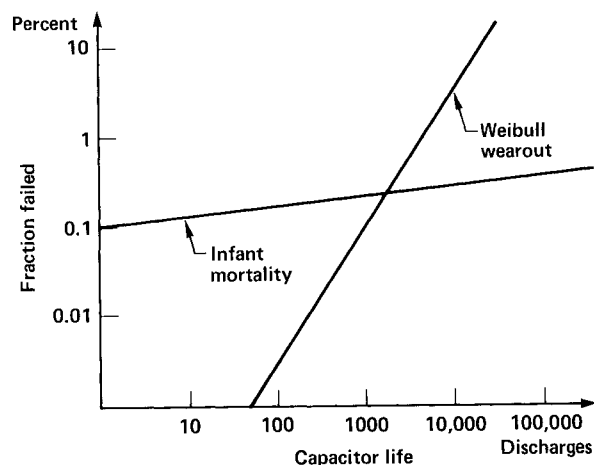
FIGURE 1

Weibull statistics describe the failure rate of a sample in the wear out mode. Early or infant mortality failures do not fall into this category nor are they described by the statistics. Figure 1 shows the shape of the Weibull curve which slowly rises monotonically from the initial level. Projecting our data for the Weibull curve into the region of less than 1,000 shots would indicate a failure rate of less than .05%. This is not observed. In fact, prior data has shown that infant mortality failures range from 1 to 7 percent depending on the quality assurance plan of the vendor³. Applying this failure rate to the Nova Bank would mean MTBF's of 10 to 20 which is undesirable. In order to remove the infant mortality failures from the distribution we embarked on the following.

CAPACITOR FAILURE VERSUS LIFE

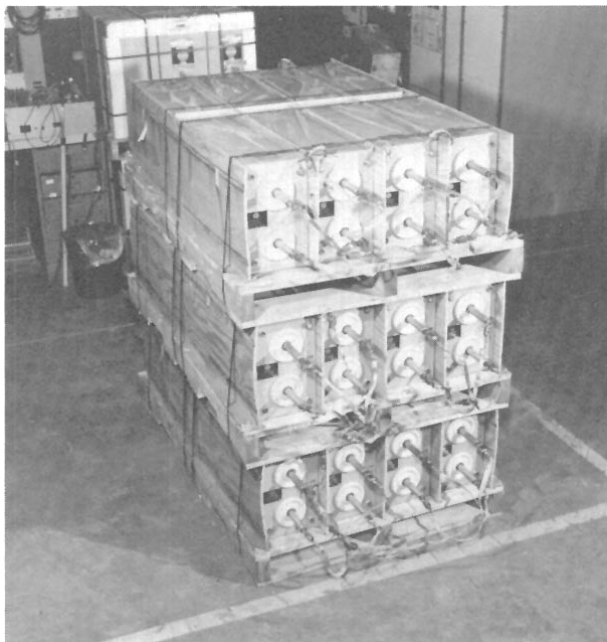
FIGURE 2

PALLETS OF CAPACITORS READY FOR HIPOT TEST

In Figure 2 are shown three pallet of capacitors ready for the high-potential test. The bushing-to-case insulation is stressed to a level of 35 kVdc for 1 minute. Four units are tested together. This test was used to eliminate bad bushings.

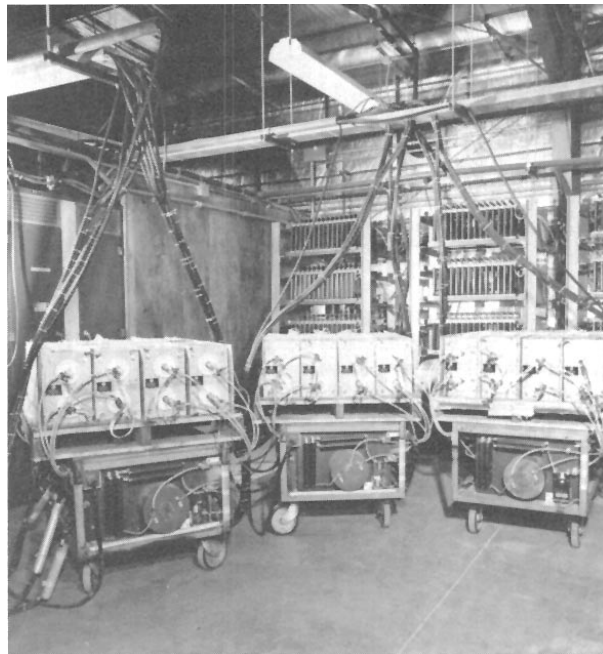
FIGURE 3

Figure 3 shows three pallets of capacitors ready for pulse-discharge testing. A description of the test circuit and hardware are given below.

PALLETS OF CAPACITORS READY FOR PULSE DISCHARGE TEST

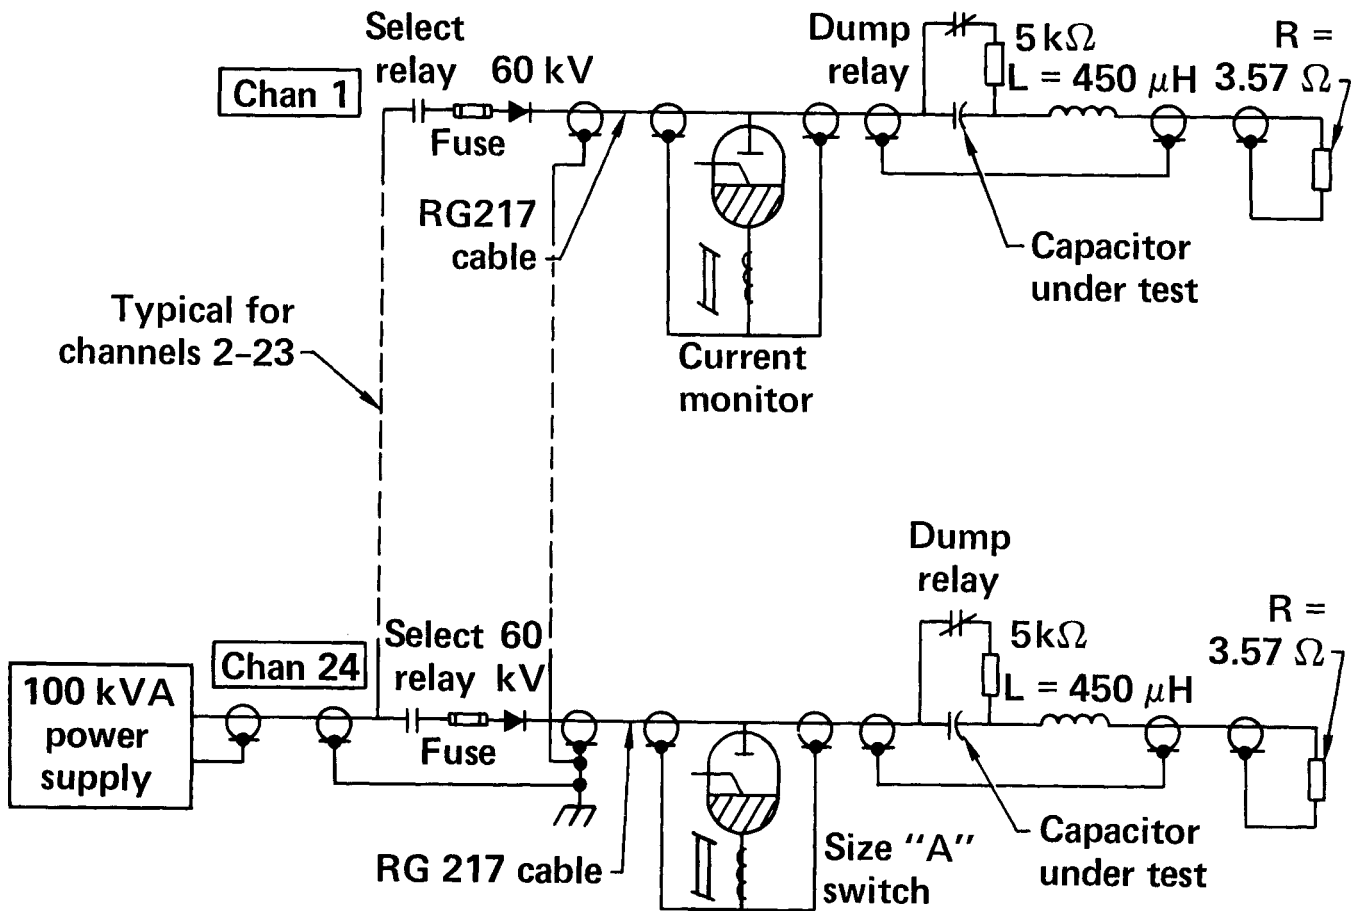
A schematic of the test circuits is shown in Figure 4. There are essentially 24 individual test circuits. Each capacitor is tested separately. Each circuit contains its own, 50 kV diode fanout (see Figure 5), size 'A' ignitron switch, 450 μ H pulse forming inductor, 3.576 Ω load bank, and dump mechanism. All circuits are charged from the same power supply. The circuits are laid out and constructed to as much as possible duplicate normal operating conditions. Figure 6 is a photograph of the control racks and power supply.

FIGURE 4
SCHEMATIC OF CAPACITOR TEST

The test was designed to run with minimum supervision. Each circuit was monitored by a current transformer. The outputs of these current transformers were input to a peak detector chassis. The peak detector chassis provides a window comparator. If the current in any circuit is too high or too low the test shuts itself down. When shutdown occurs, the test was "safed" out and the cause determined. If a failed capacitor was found, that capacitor was deselected. Each of our circuits were individually selectable by Ross switches in the fanout, so that, if a failure occurred, the failed circuit would be remotely disconnected and the test continued.

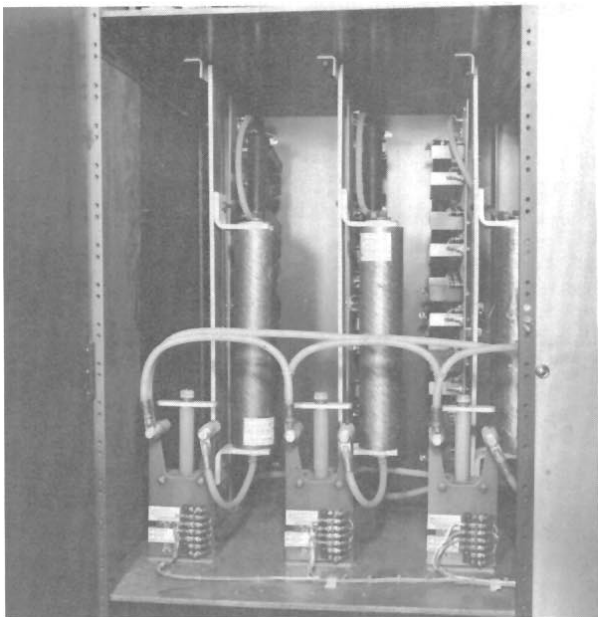
FIGURE 5
50 kV DIODE FANOUT

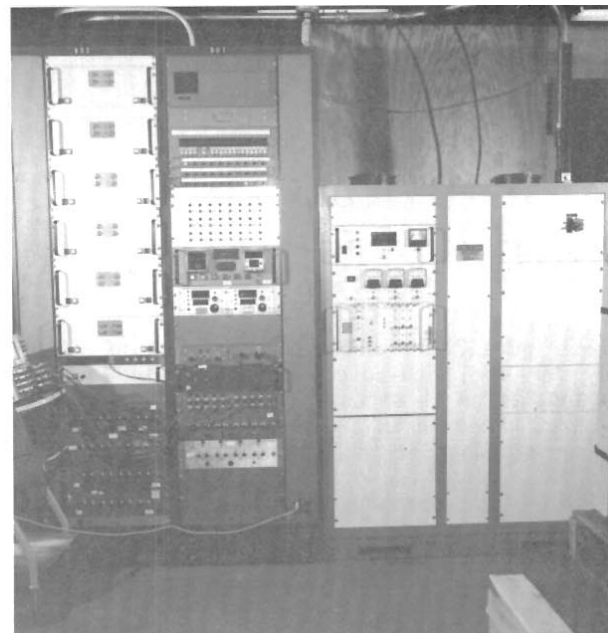
FIGURE 6
CONTROLS RACKS AND POWER SUPPLY
